Manhole Inspection Summary

Manhole # S19GG2072MH

Record Plat: **19GG2** Node: **072** Status: **New Manhole (Not in GIS)** Insp Date: **10/3/06 12:00 AM**

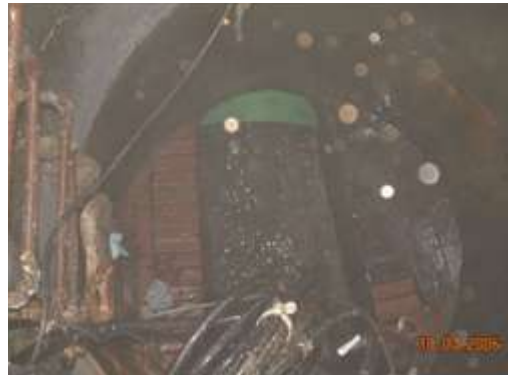
Top View

Bench ☒ Exists Material: **Brick** ☐ Parged ☒ **Debris** (not Condition related)

Surcharge ☒ **Evidence Of Surcharge** Depth: **11** (ft.) ☐ Active Surcharge Present

Evidence of surcharge - Bench debris.

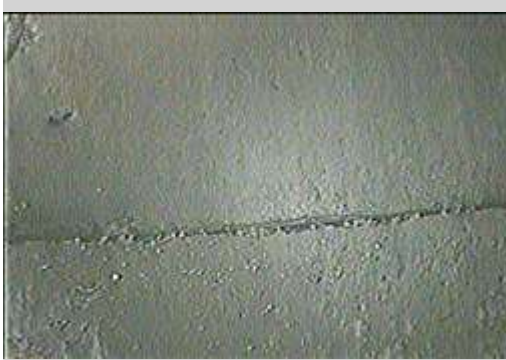
Defect

Infiltration: ☐ None ☒ **Joint** ☐ Cracks ☐ Mortar ☐ Roots ☐ Wall

Barrel infiltration.

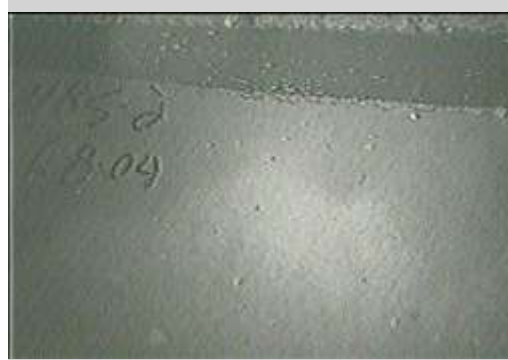
Defect

Infiltration: ☐ None ☒ **Joint** ☐ Cracks ☐ Mortar ☐ Roots ☐ Wall

Corbel infiltration.

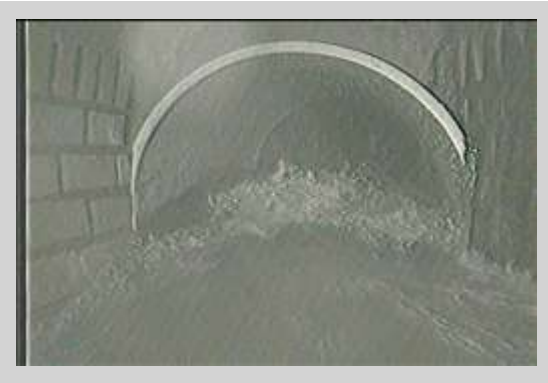
24 in. Circular Gravity Sewer Pipe Out @ 12 O'Clock

Infiltration: **Weeper** Pipe Seal Cond: **Unknown**
